AFML-TR-76-81-PT-4

DEFECT-PROPERTY RELATIONSHIPS IN COMPOSITE MATERIALS

K. L. Reifsnider, E. G. Herneke, II and W. W. Stinchcomb

Final Report

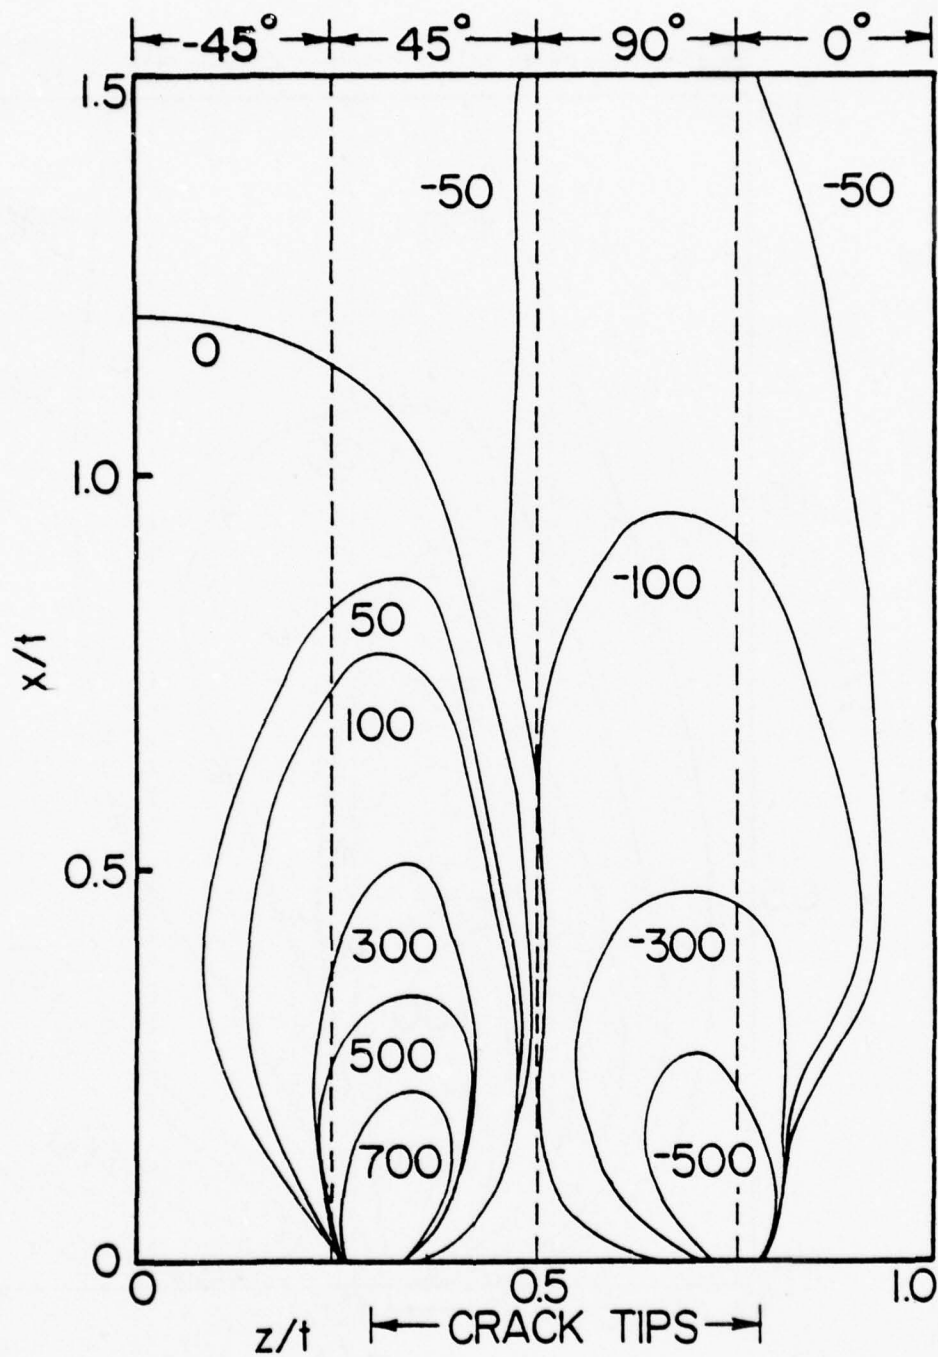
Figure 42. Contours of  $\tau_{xz}$  (psi) for a type II laminate with  $90^\circ$  and  $45^\circ$  ply damage

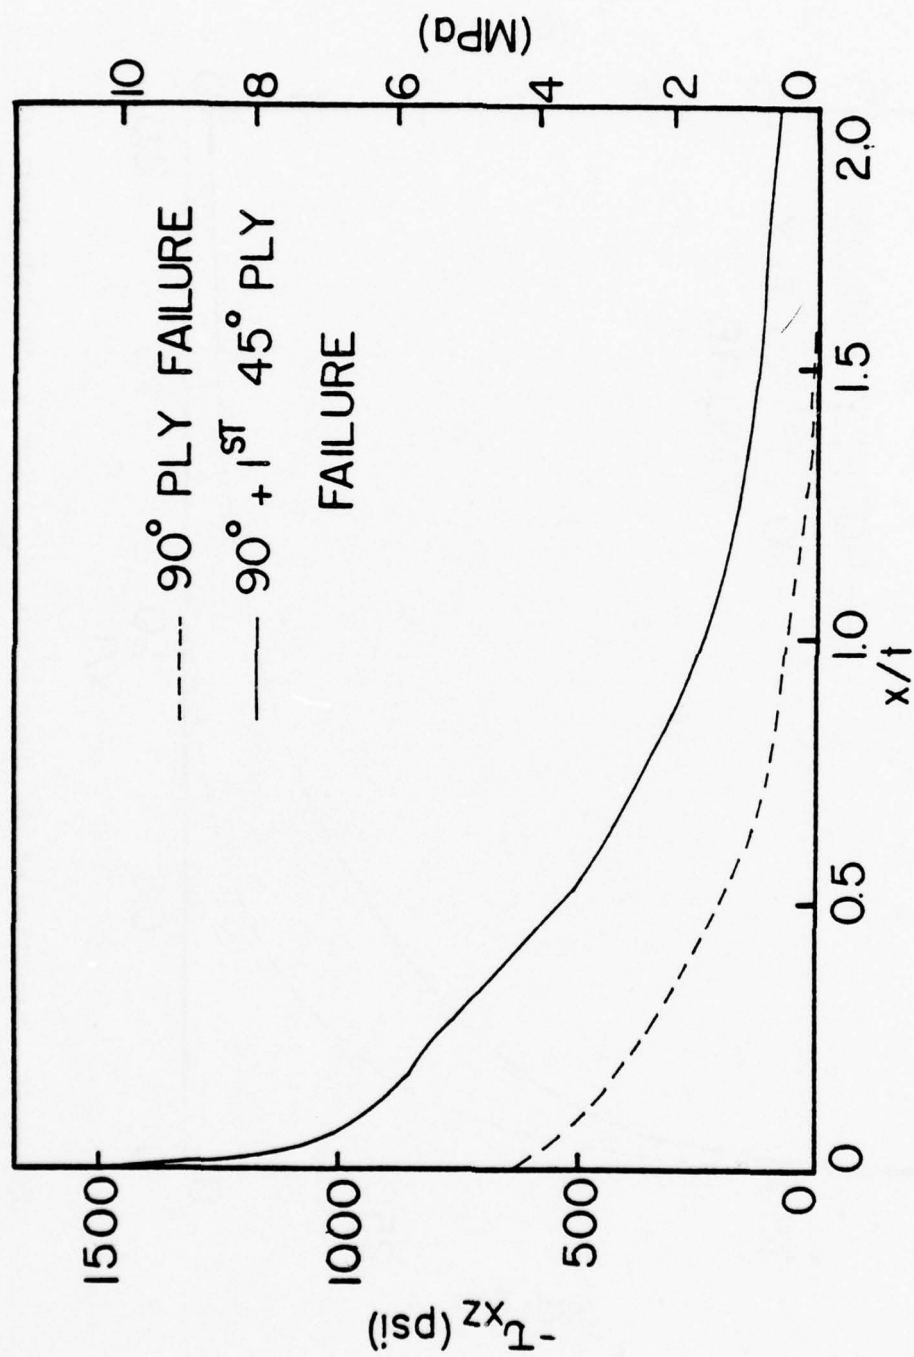
Figure 43. Variation of the shear stress,  $\tau_{xz}$ , with  $x$  directly above the crack tip for damaged type I laminates

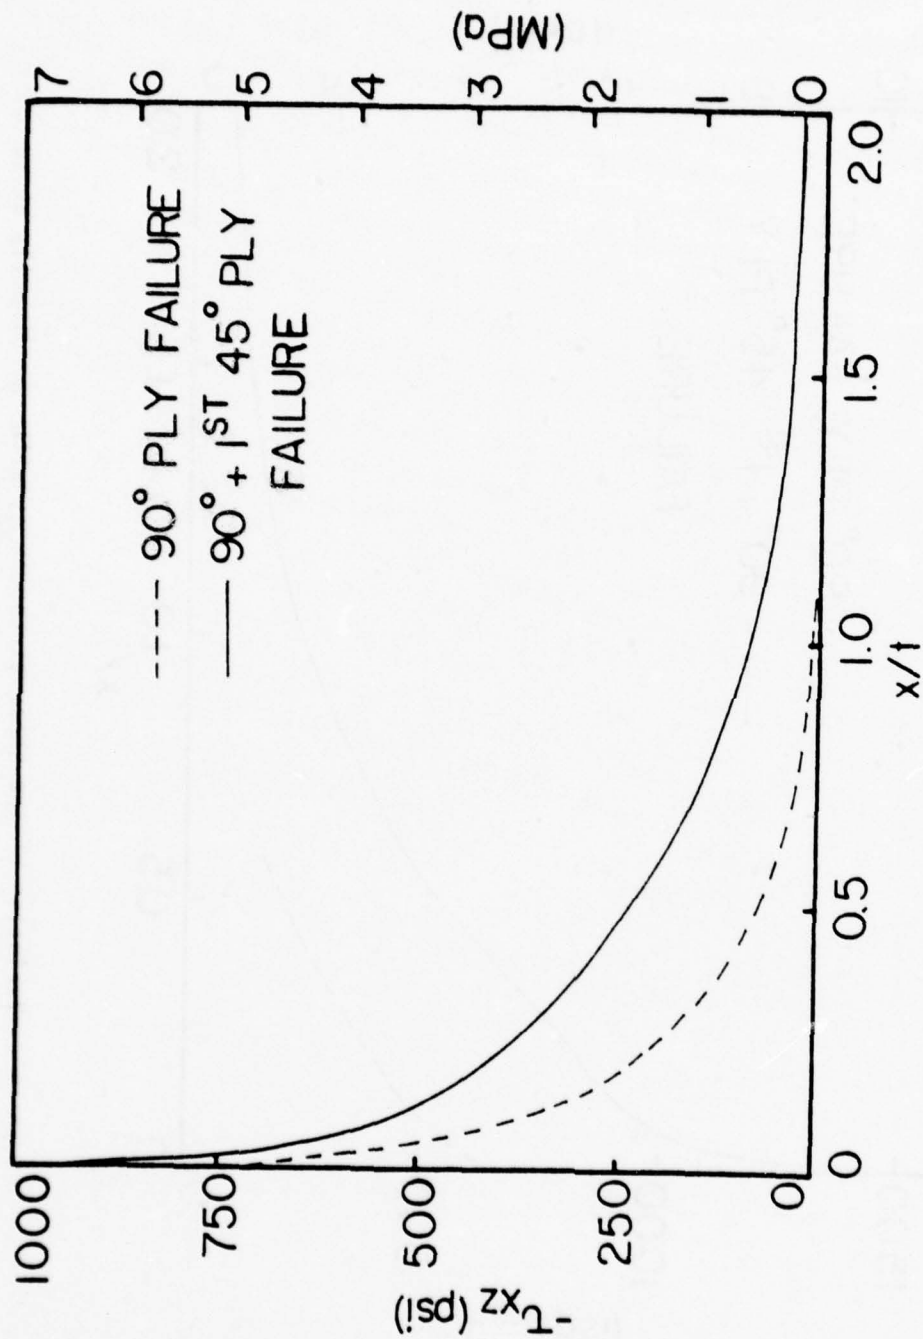
Figure 44. Variation of the shear stress,  $\tau_{xz}$ , with  $x$  directly above the crack tip (within the 0° ply) for damaged type II laminates

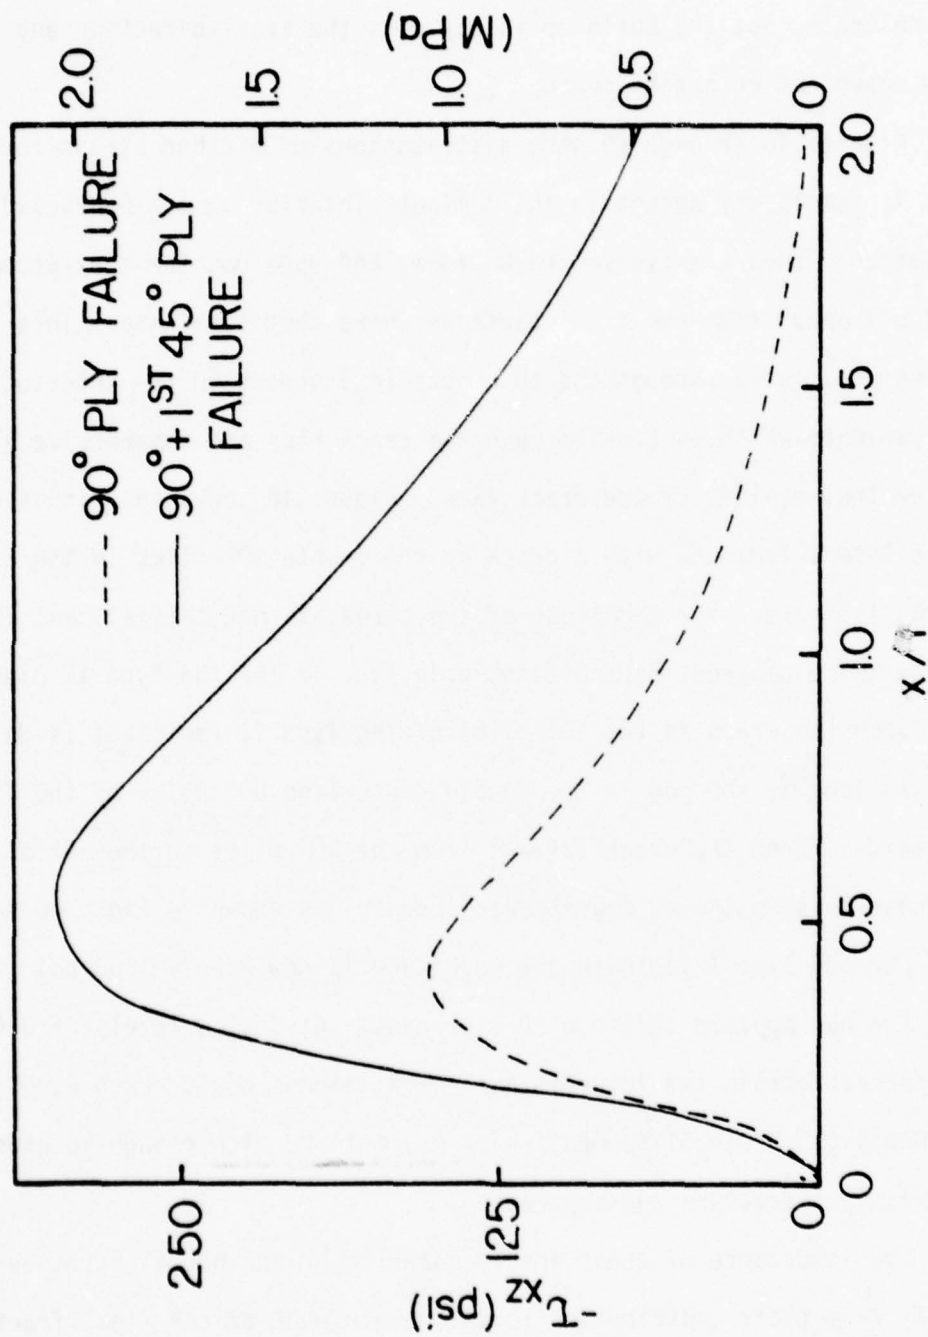
Figure 45. Variation of the shear stress,  $\tau_{xz}$ , with  $x$  above the first node ahead of the crack tip for damaged type I laminates

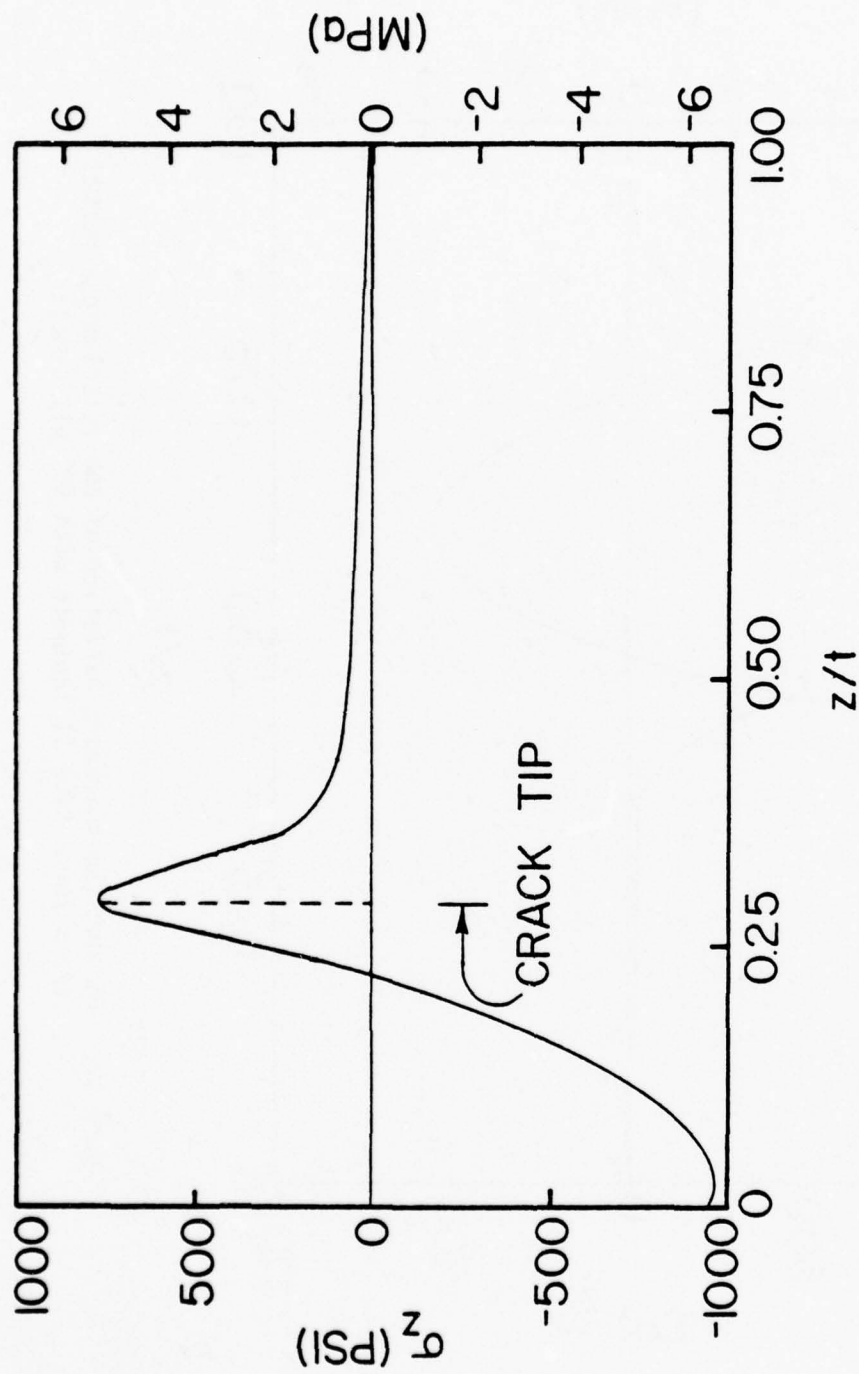
Figure 46. Through-the-thickness variation of the interlaminar normal stress for a type I laminate with 90° ply damage.

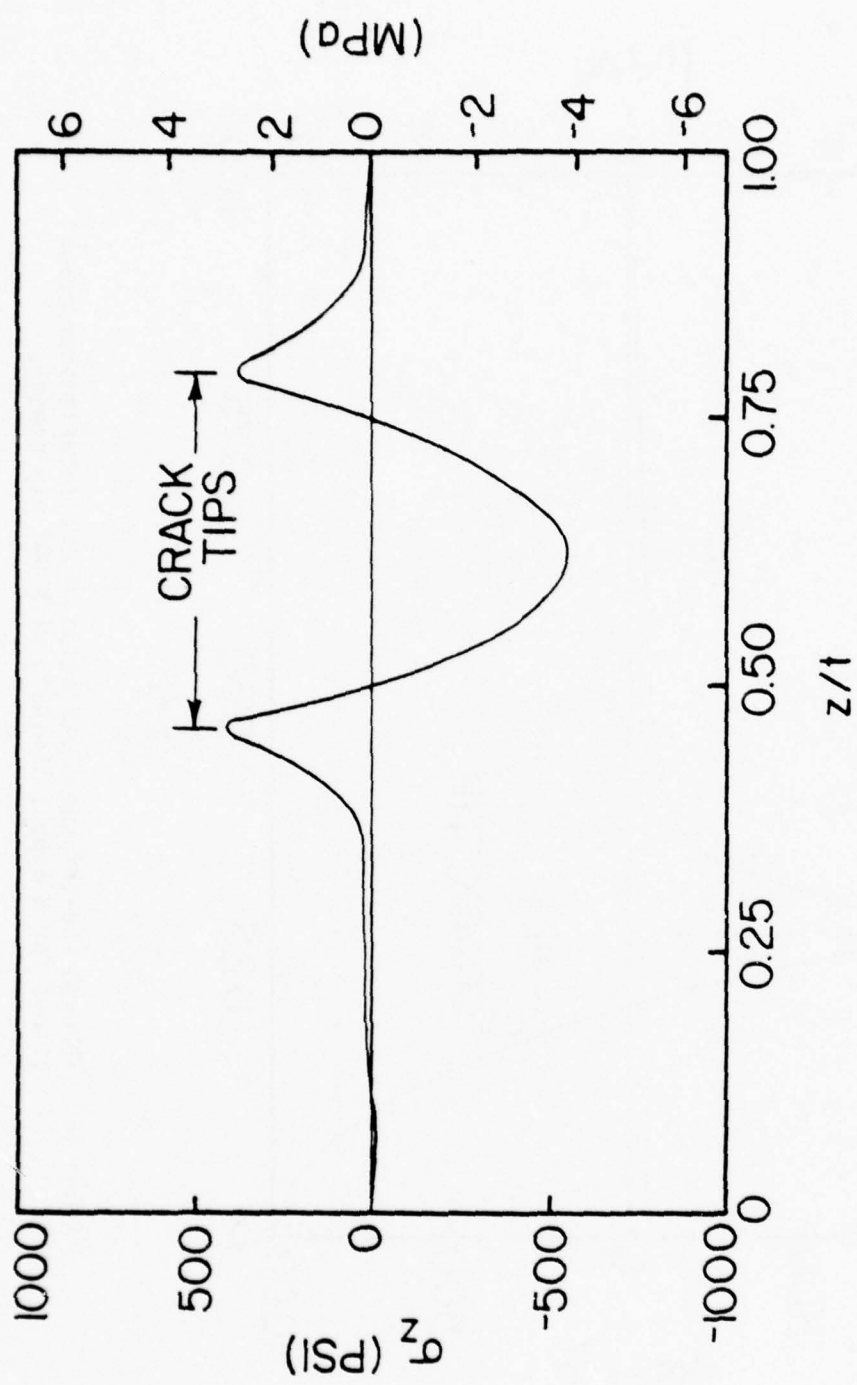
Figure 47. Through-the-thickness variation of the interlaminar normal stress for a type II laminate with 90° ply damage.

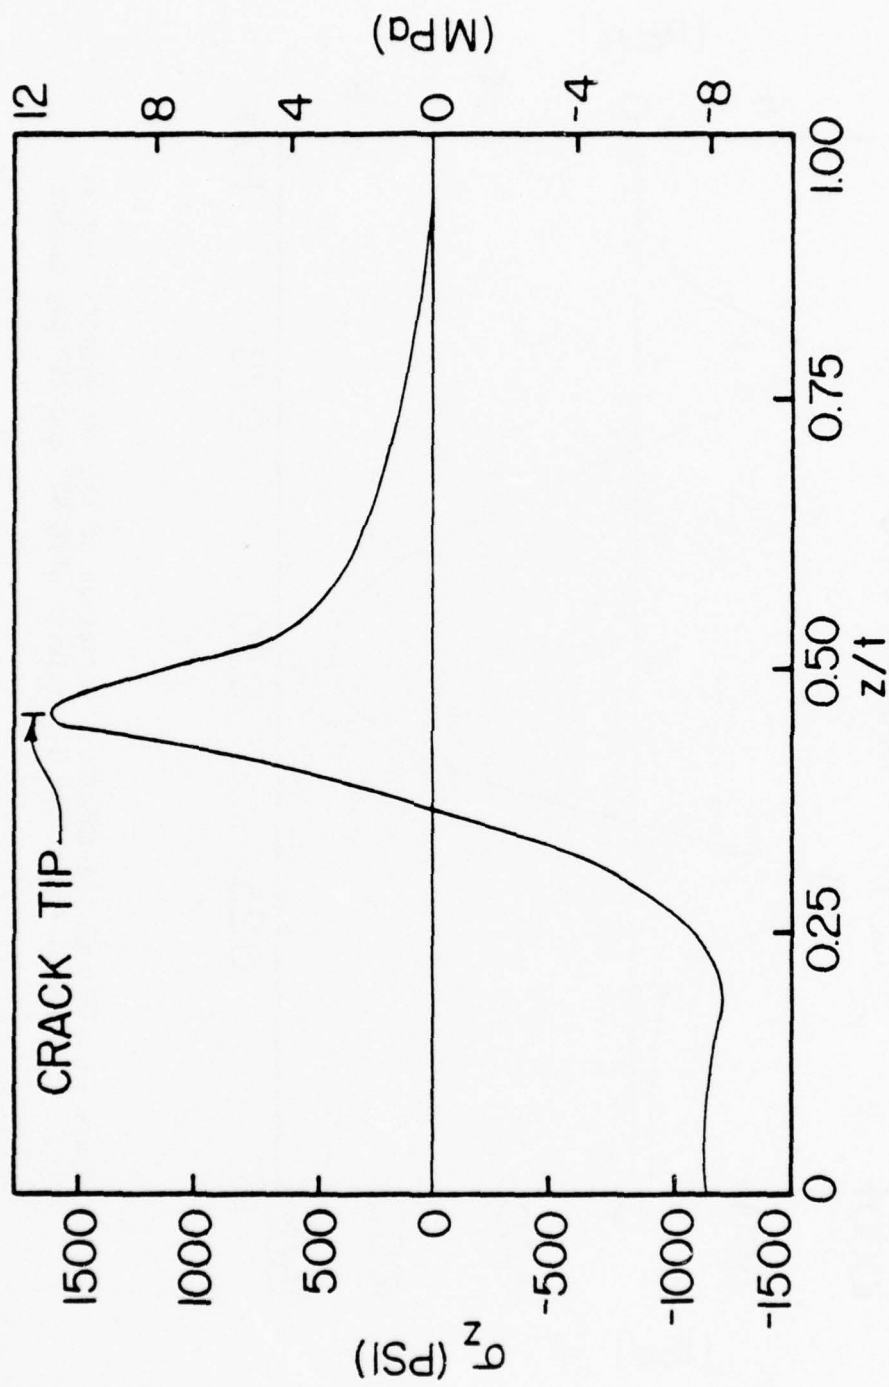
Figure 48. Through-the-thickness variation of the interlaminar normal stress for a type I laminate with 90° and -45° ply damage

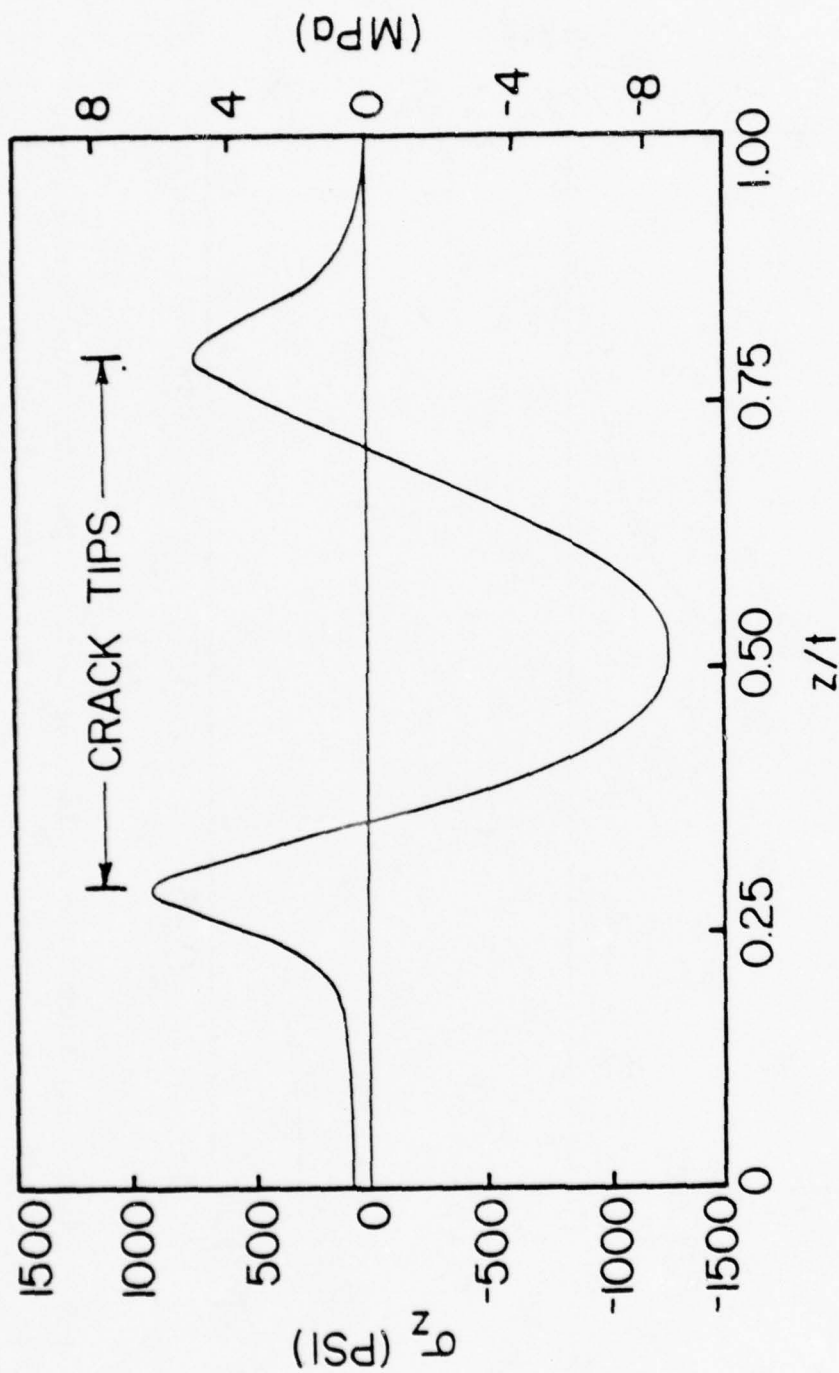
Figure 49. Through-the-thickness variation of the interlaminar normal stress for a type II laminate with 90° and 45° ply damage.

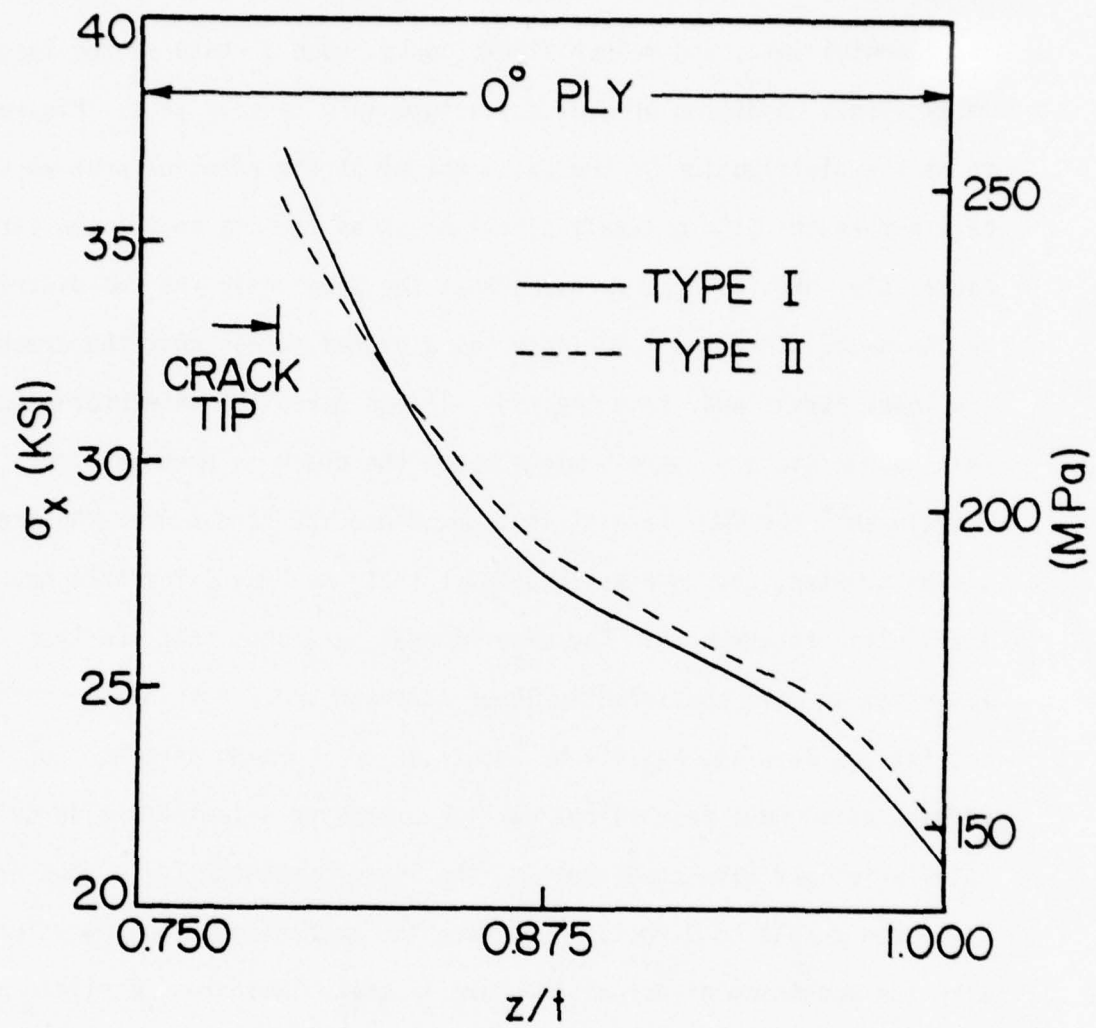
Figure 51. Through-the-thickness variation of  $\sigma_x$  ahead of the crack tip for complete off-axis ply failure. (After the crack extends into the  $0^\circ$  ply.)

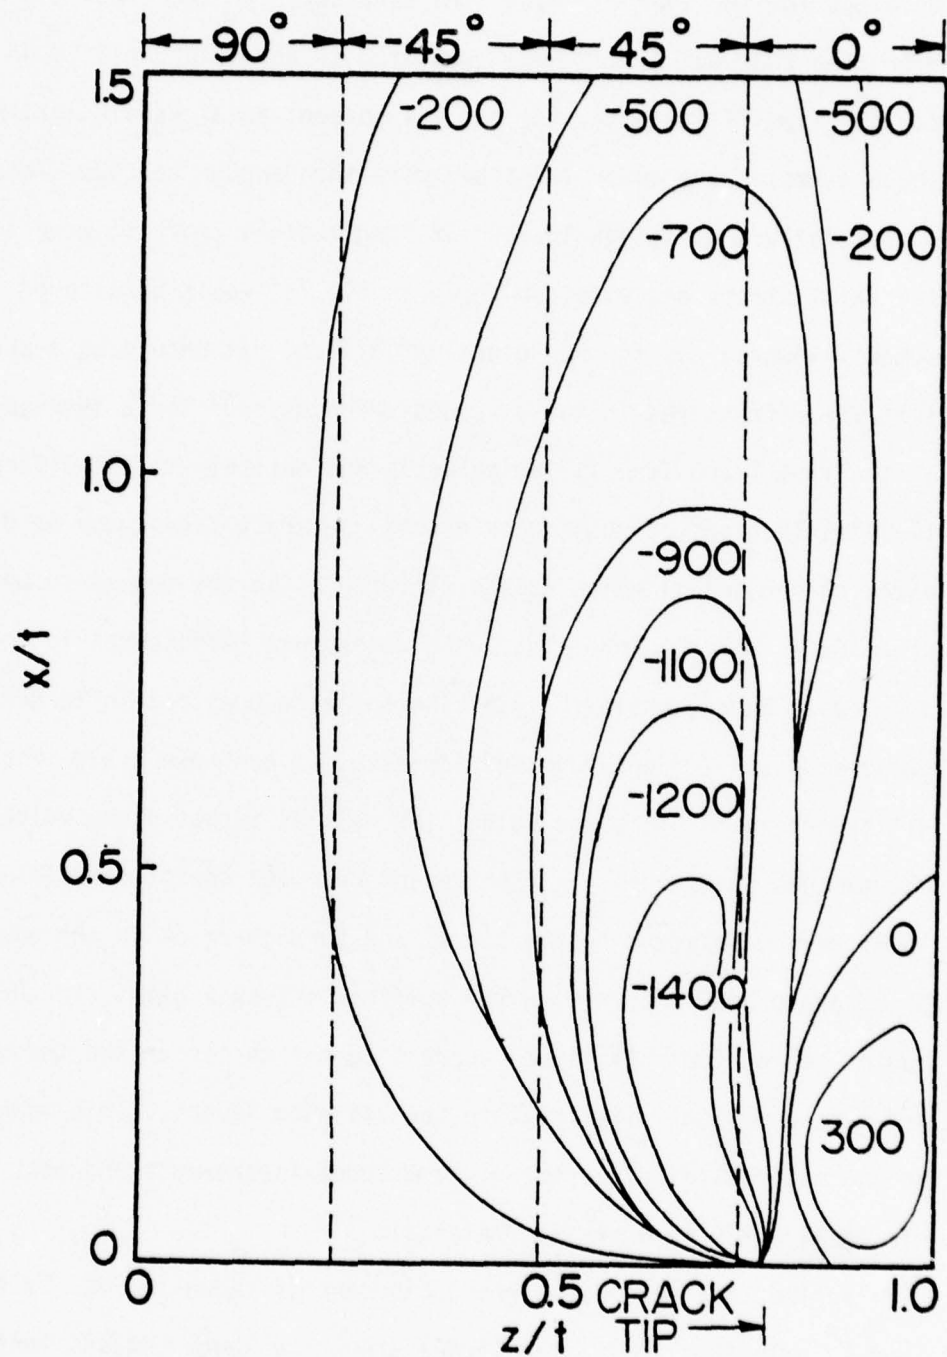
Figure 52. Contours of  $\tau_{xz}$  (psi) for a type I laminate with complete off-axis ply failure.

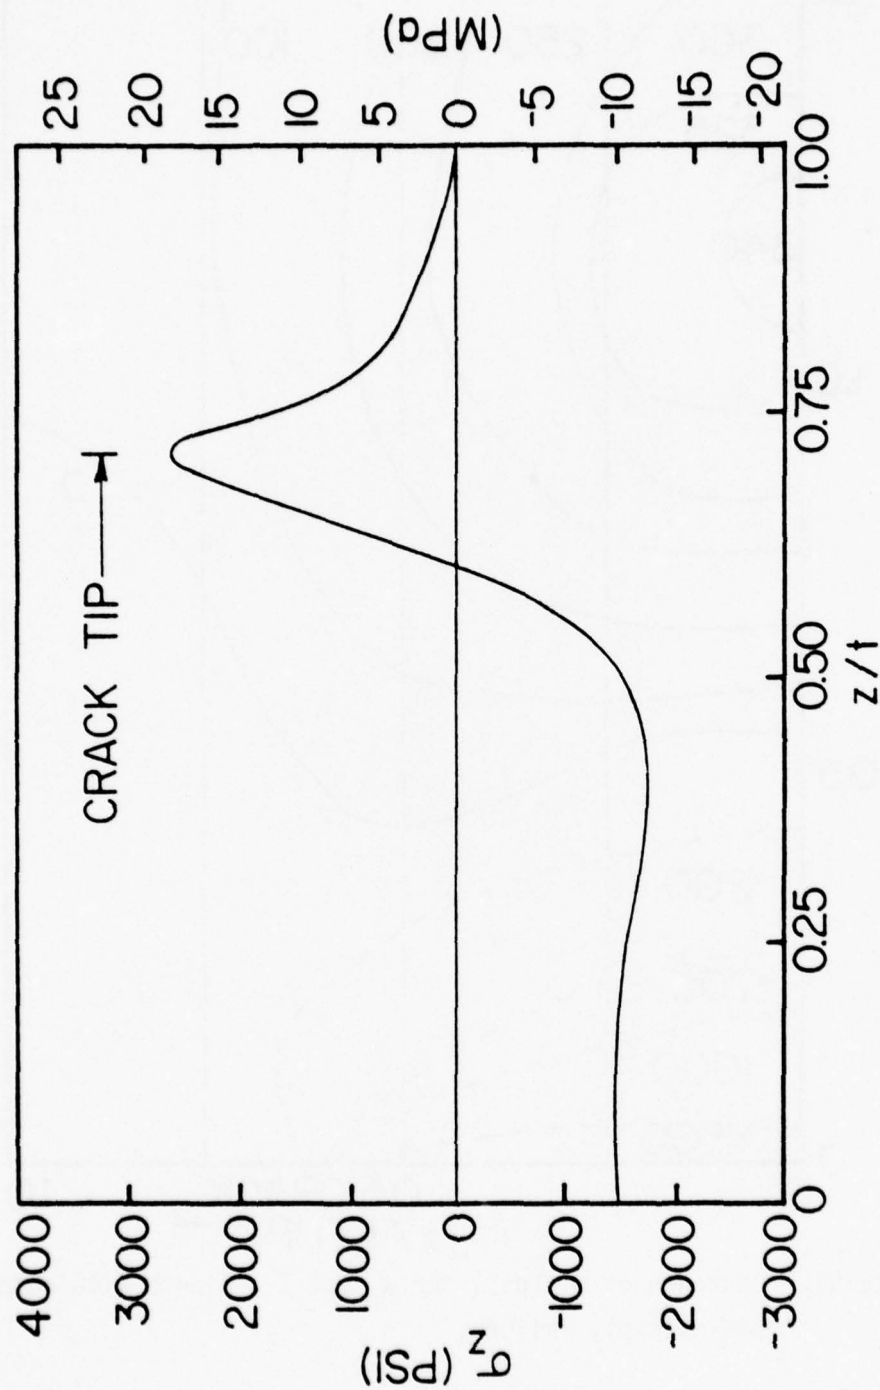
Figure 53. Through-the-thickness variation of  $\sigma_z$  for a type I laminate with complete off-axis ply failure. (Before the crack extends into the  $0^\circ$  ply.)

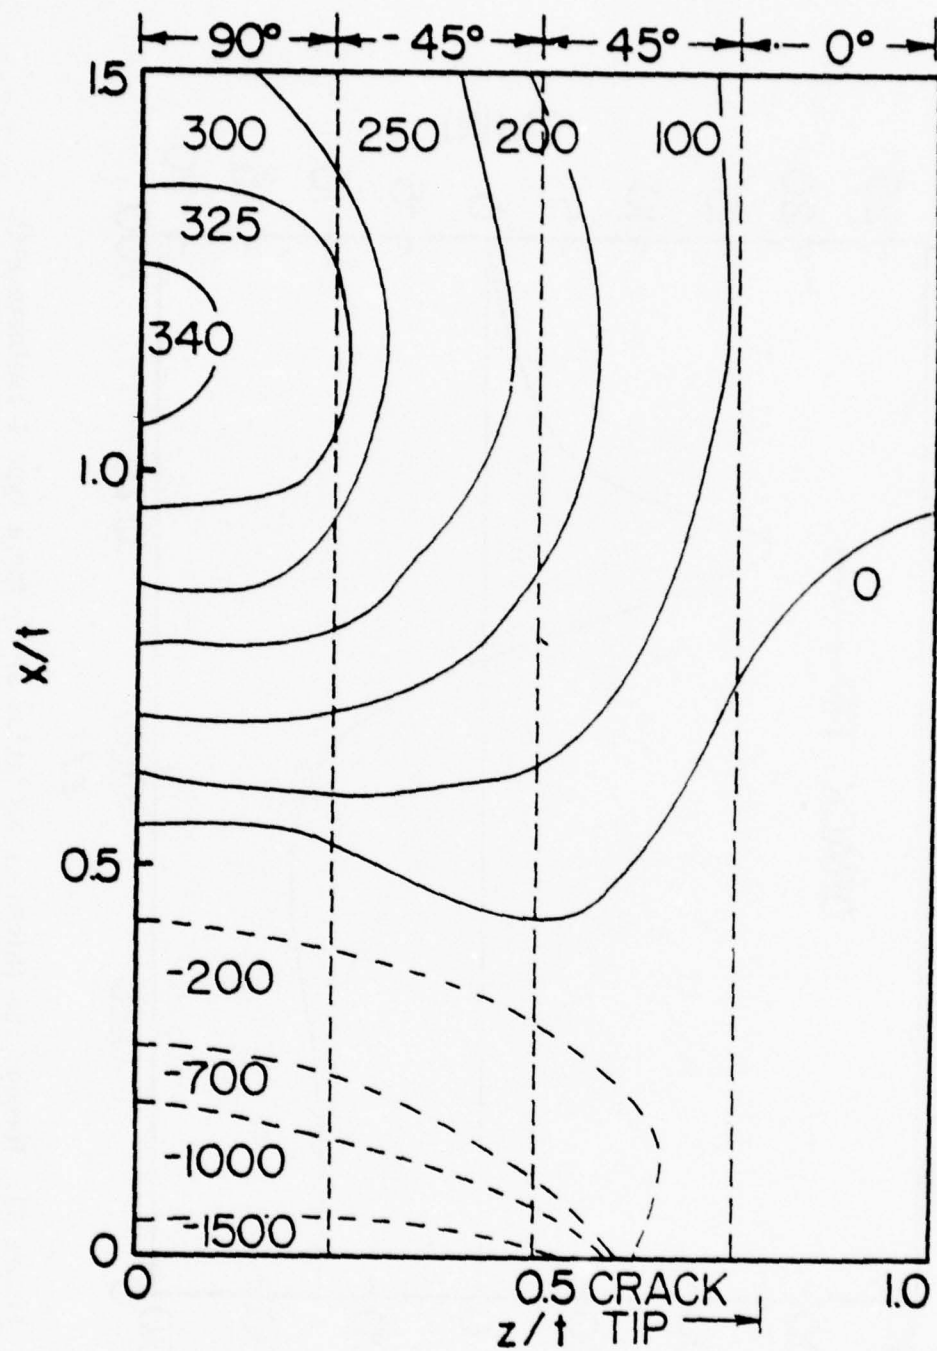
Figure 54. Contours of  $\sigma_z$  (psi) for a type I laminate with complete off-axis ply failure.

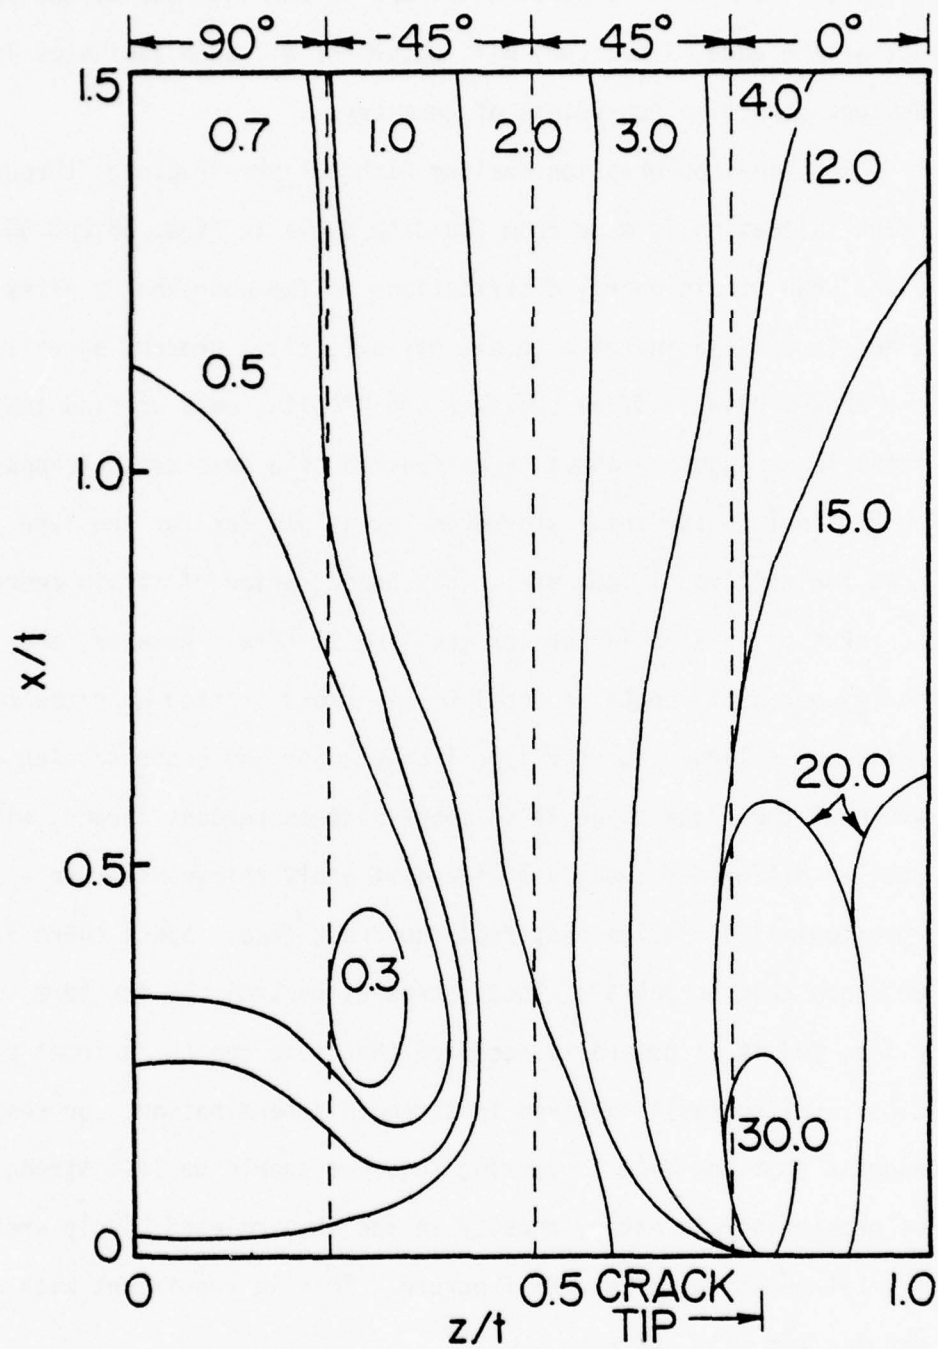
Figure 55. Contours of strain energy (psi) for a type I laminate with complete off-axis ply failure.

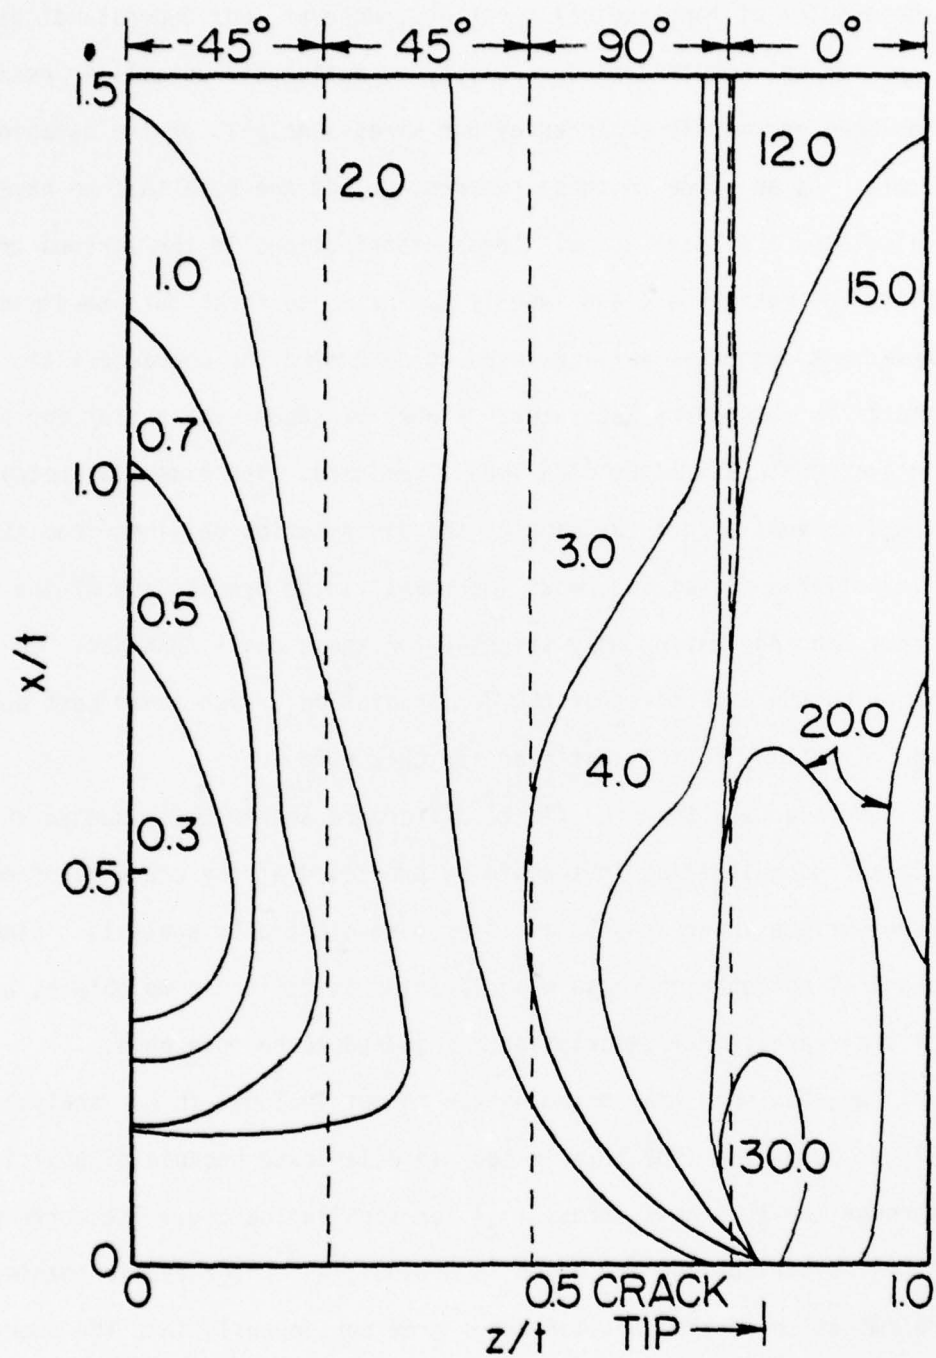
Figure 56. Contours of strain energy (psi) for a type II laminate with complete off-axis ply failure

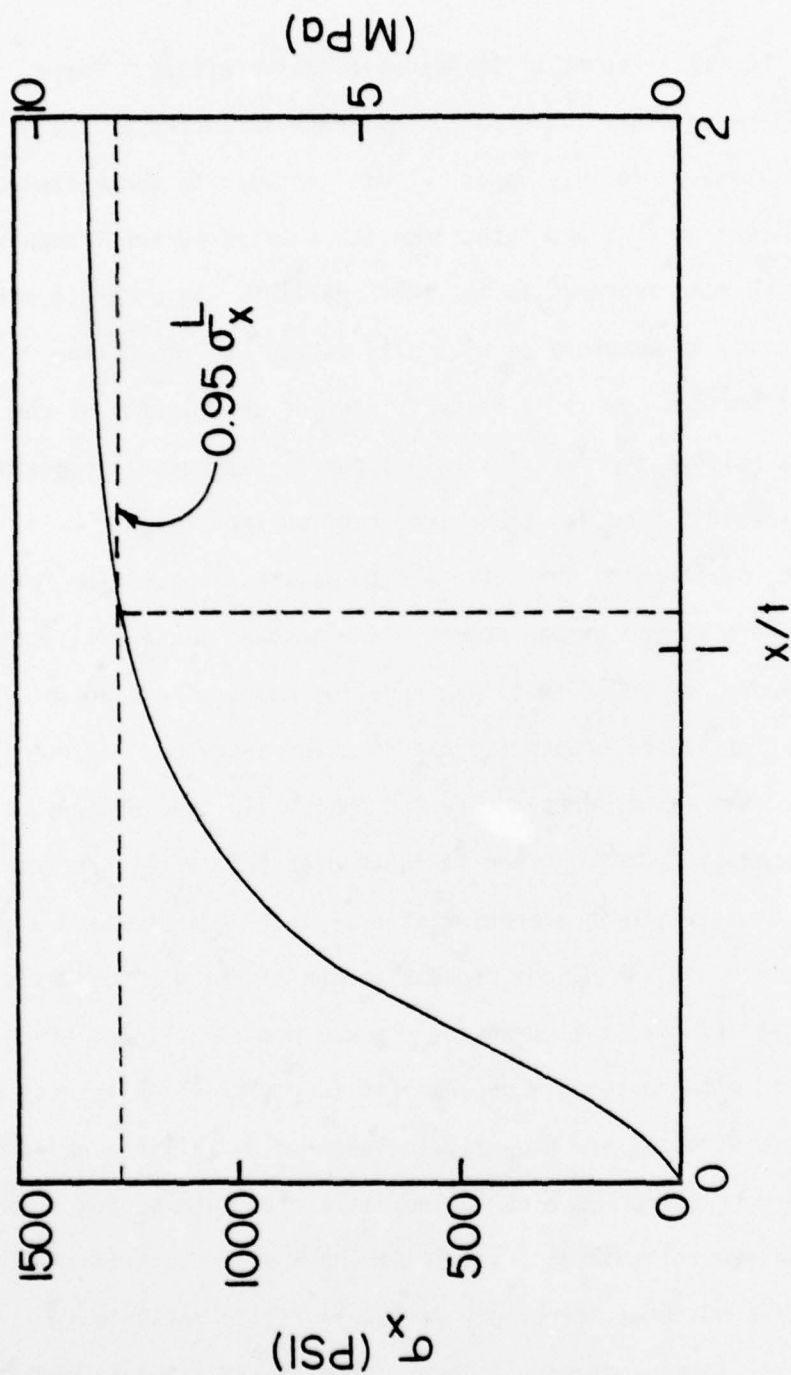
Figure 57. Variation of  $\sigma_x$  with the distance from the crack surface for a type I laminate with  $90^\circ$  ply damage.

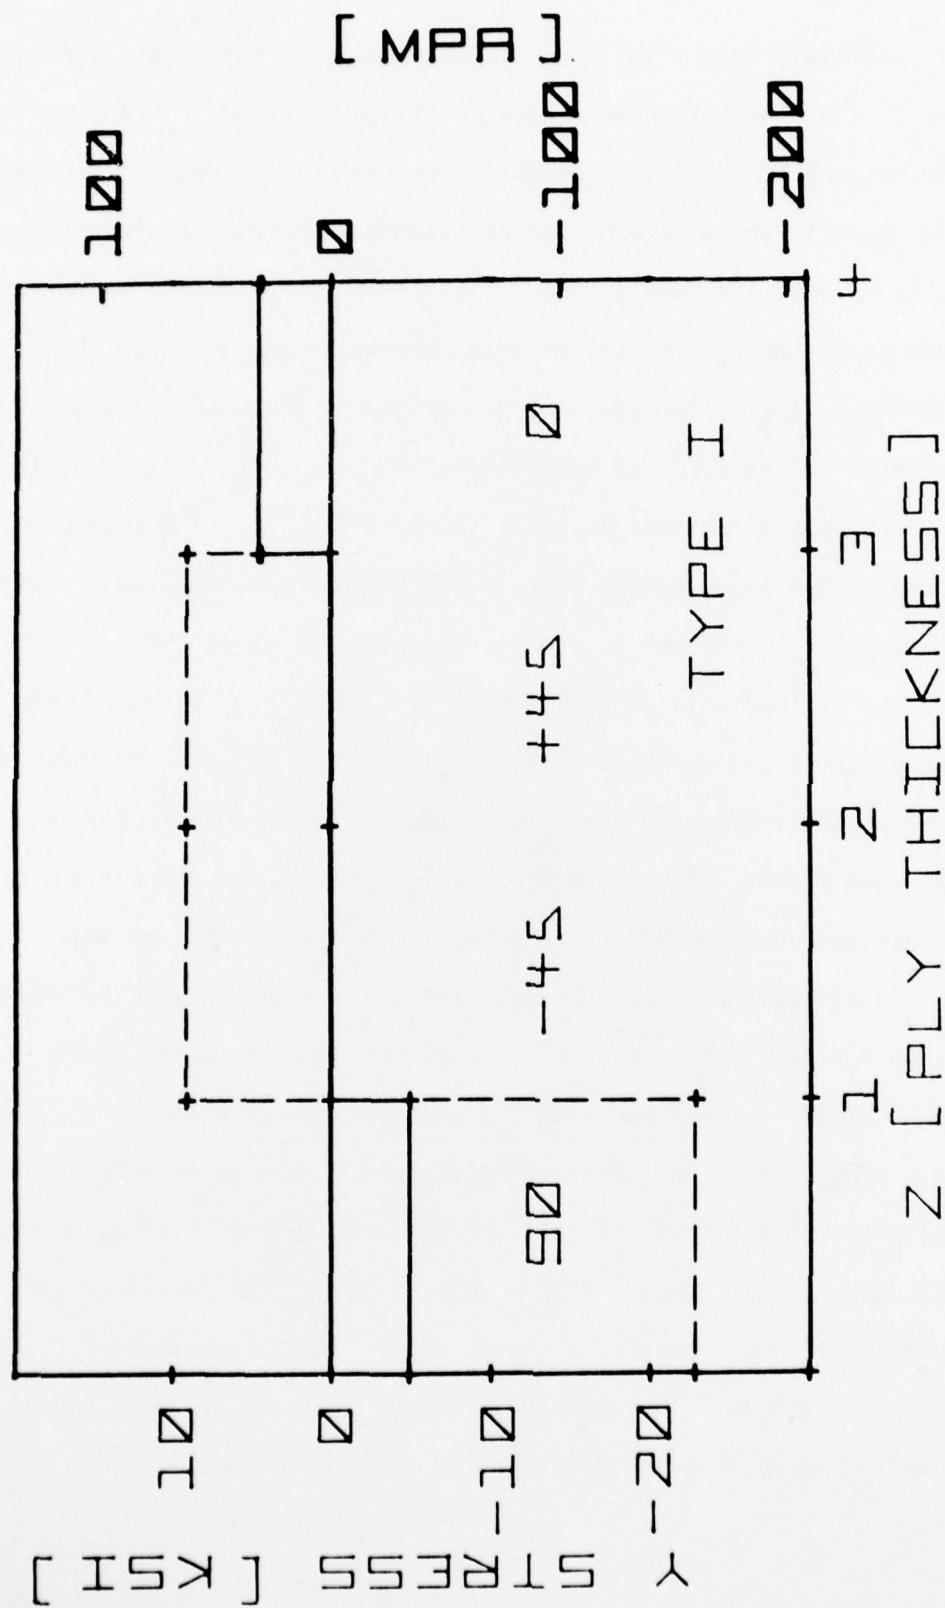
Figure A1. Transverse in-plane normal stress in a  $[0, \pm 45, 90]_s$  laminate. The thermal residual stresses are shown by the solid lines while the stresses due to a 4.45 kN applied load are shown by the dotted lines.

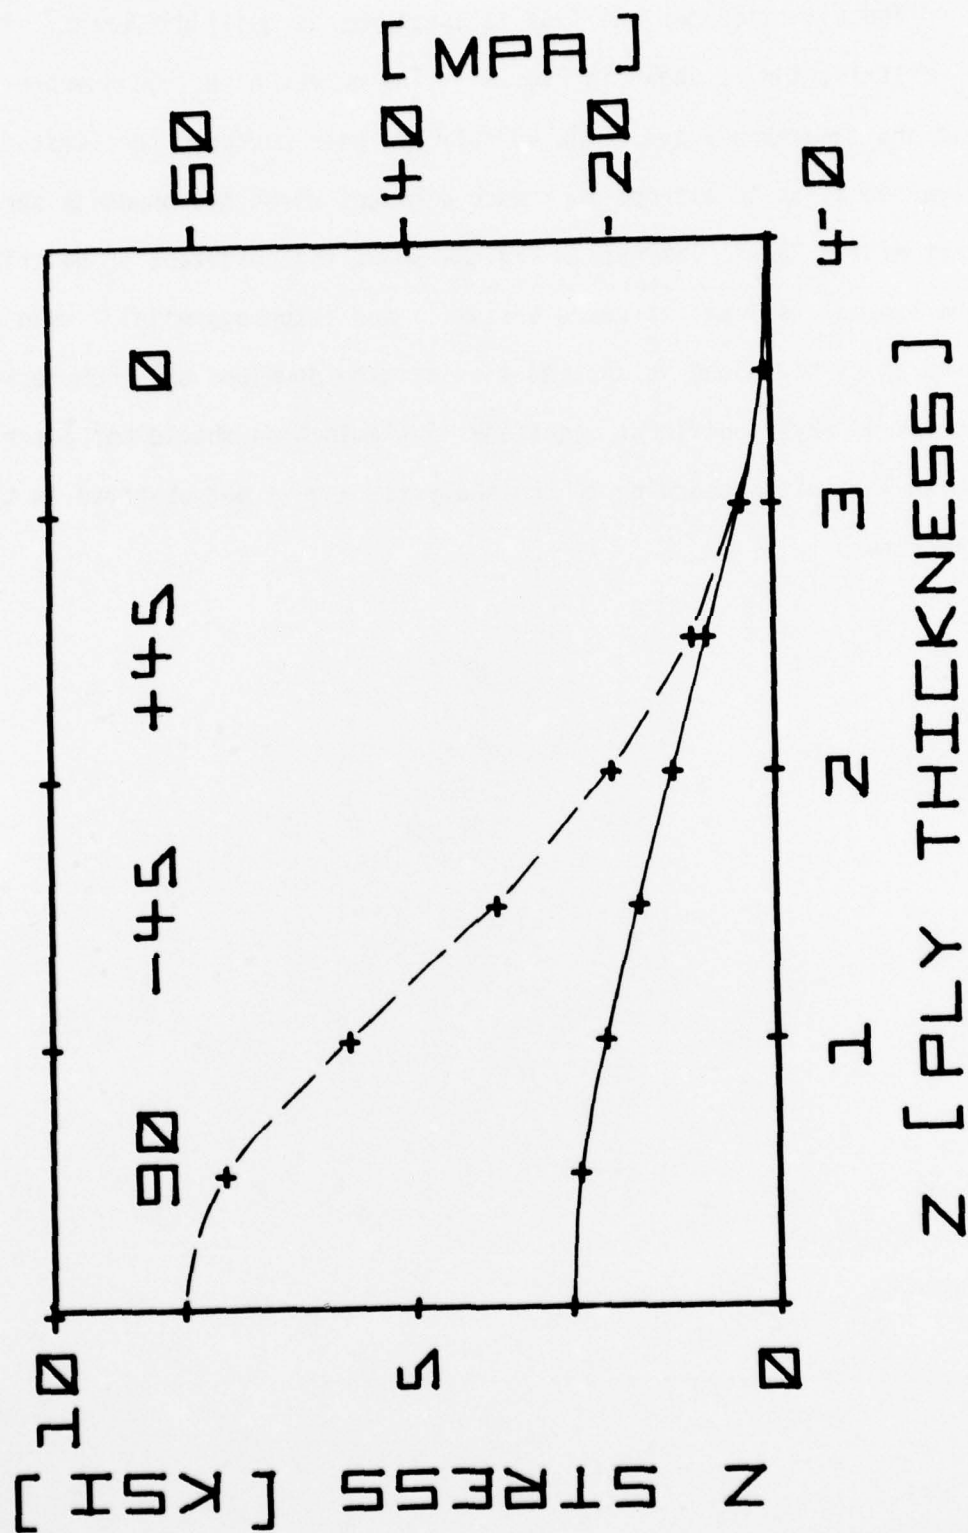
Figure A2. Through-the-thickness " $\sigma_z$ " stress distribution for a  $[0, \pm 45, 90]_s$  laminate.
